Foundation Inspection Report

Dwelling type:	House and Garage.
Dwelling configuration:	Single Storey
Nature of works:	New Building.
Stage of inspection:	Foundations.
Construction Type:	Brick Veneer.
Garage:	Attached.
Foundations:	Raft Slab.
Builder:	<i>Details hidden for privacy</i>

An inspection was conducted at the above address on 9/11/2014 for the purpose of a general home inspection, requested by the 'client'.

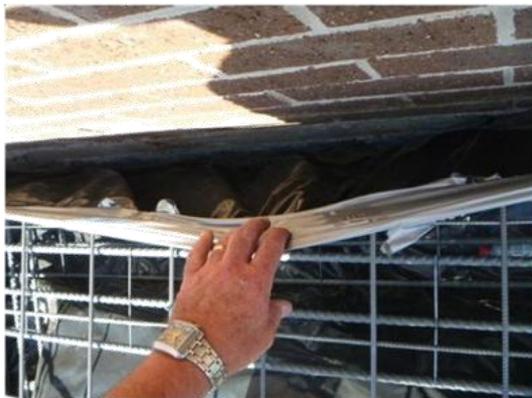
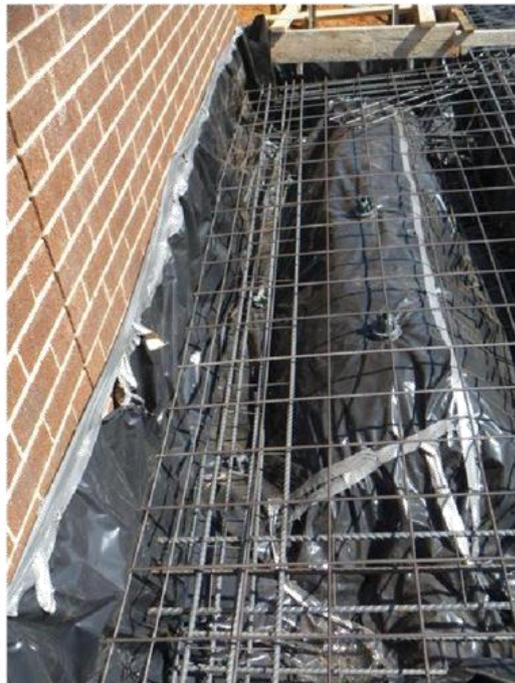
1. Garage - the slab abutment to the neighbouring slab edge has not been set up with a bond breaking flexible product such as ableflex.

I noted that the connection between the adjoining property and my clients has no provisions for isolation and it appears that other than the vapour barrier plastic, this part of the BCA has not been complied with.

The performance requirements of the BCA mandate that this isolation is in place. It is more than likely that any movement on either site will impact on the other. This creates a multitude of legal questions should one or the other of the dwellings suffers cracking or movement.

The builder must make good this defect prior to moving forward with the build.

I refer the builder to the BCA part 3.1.1.3.

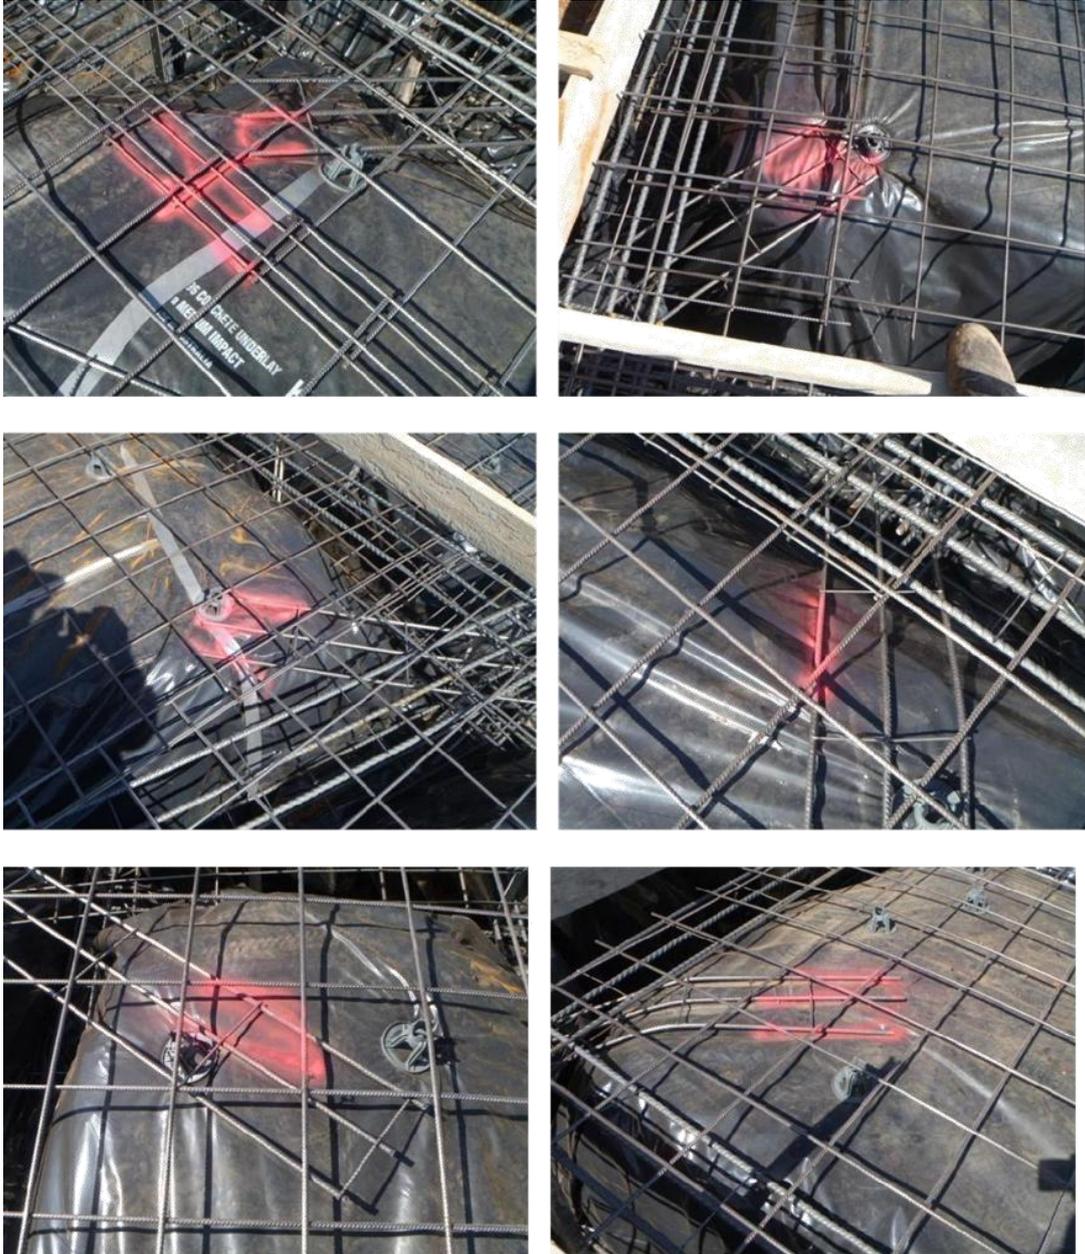
2. There are numerous areas where the reinforcement fabric is sitting on or touching the vapour barrier.

The reinforcement fabric is designed to be located within the top 1/3 of the slab. The current installation puts the mesh within the bottom 1/3 or touching the actual slab support base.

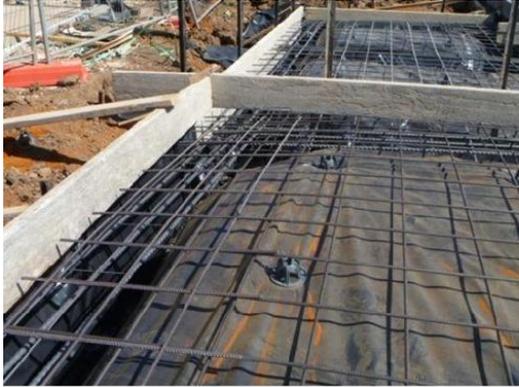
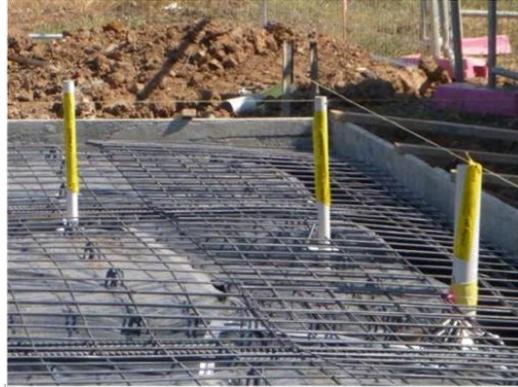
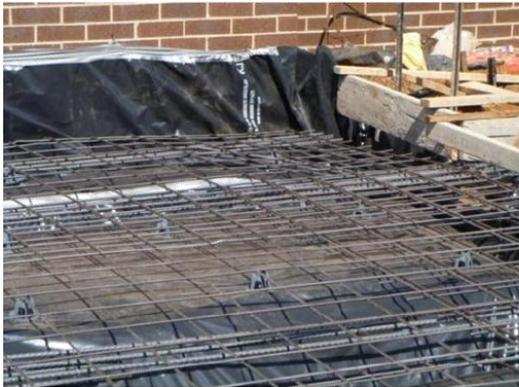
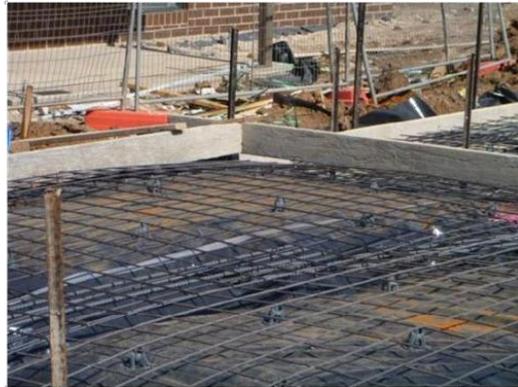
3. The biggest concern is the amount of drop in the reinforcement mesh at the perimeter and external corners of the property.

Being there is a wide strip footing and bulk concrete this mesh is sagging well below the finished height line of 25mm below to top of the concrete.

Ideally this mesh should be supported with timber diagonally across the boxing and wires to hold it up.

At the very least the concreter needs to be vigilant on the day of pour to lift it up into position with a hook.

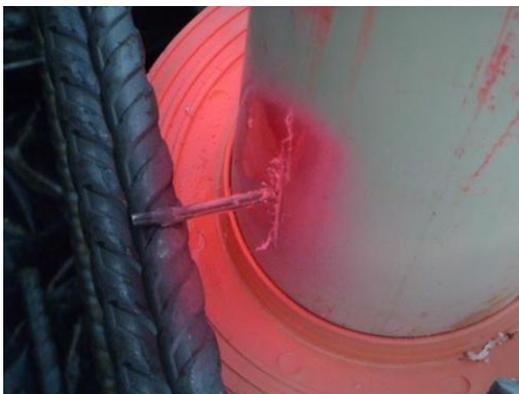
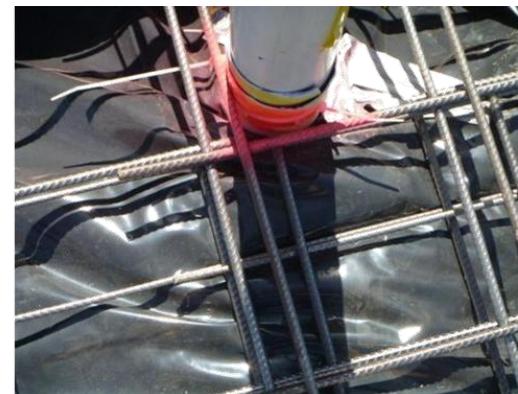
4. A number of the sewer pipes are touching the reinforcement mesh.

This mesh will need to be cut away to clear the pipes.

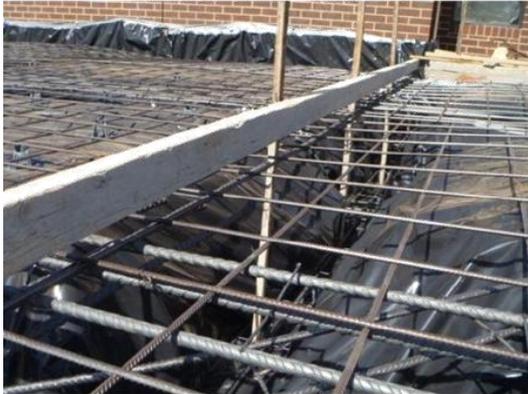
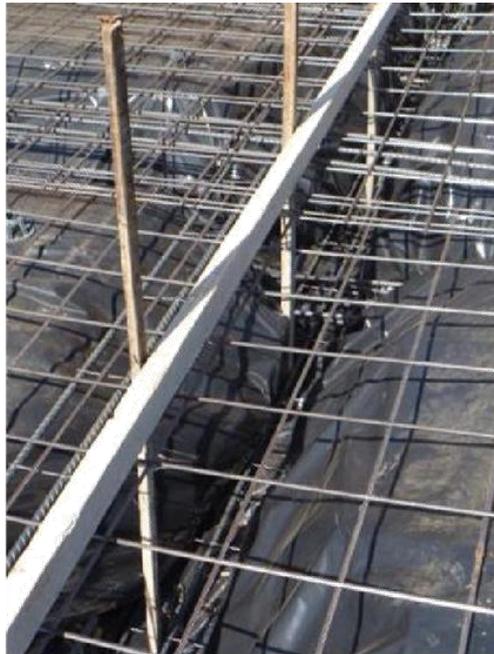
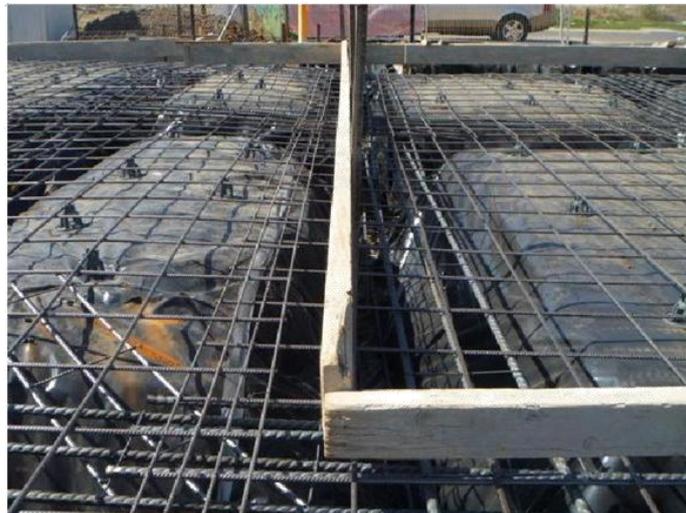
6. Front - the angled cracker bars are shown on the slab engineering to be sitting within the raised pad area.

The current installation puts these cracker bars outside the line of the raised pad and as such will need readjusting into position.

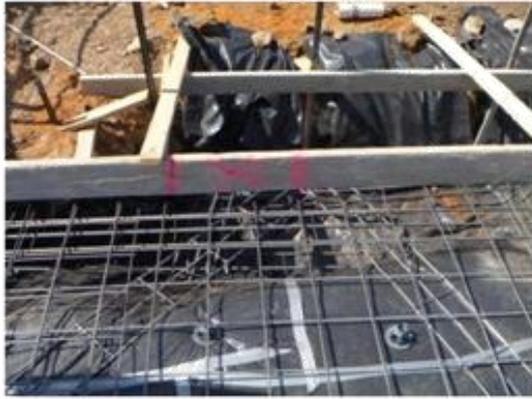
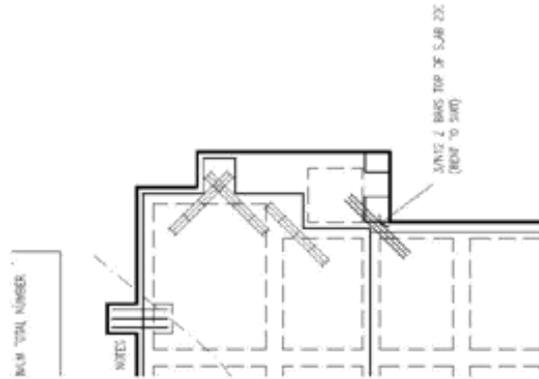
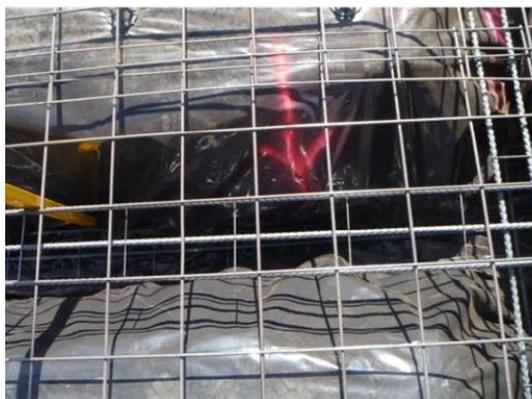
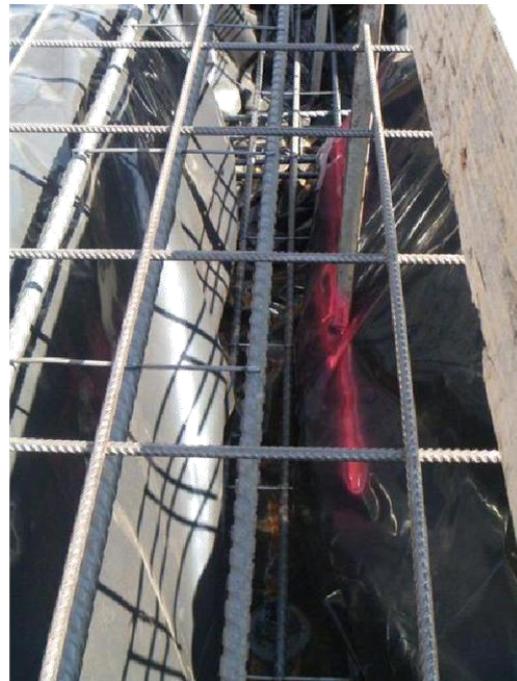
7. The sand base below the vapour barrier has collapsed into the beams in a number of areas.

This is a common issue but normally not this extreme. The sand is covering two thirds of the beam in some areas and only the one of the three trench mesh bars is visible.

The builder will need to rework the sand within these beams to provide the full beam width as per the engineering.
